FINAL REPORT
F SERIES
STAGING
MOCK-UP INVESTIGATION

Project CLASP was an extensive investigation of "E" and "F" Series Atlas Missile System failures in order to analyze, isolate and define the critical areas associated with staging, guidance and other problems that may have been defined and to devise and prepare design fixes to correct the problems.

An investigation of possible problem areas in the staging of Atlas "E" and "F" missiles was conducted as a portion of the program in order to determine the mode of failure of 71E, 6F, and 138F. The failure of the three missiles was directly attributed to loss of sustainer hydraulic pressure after initiation of staging.

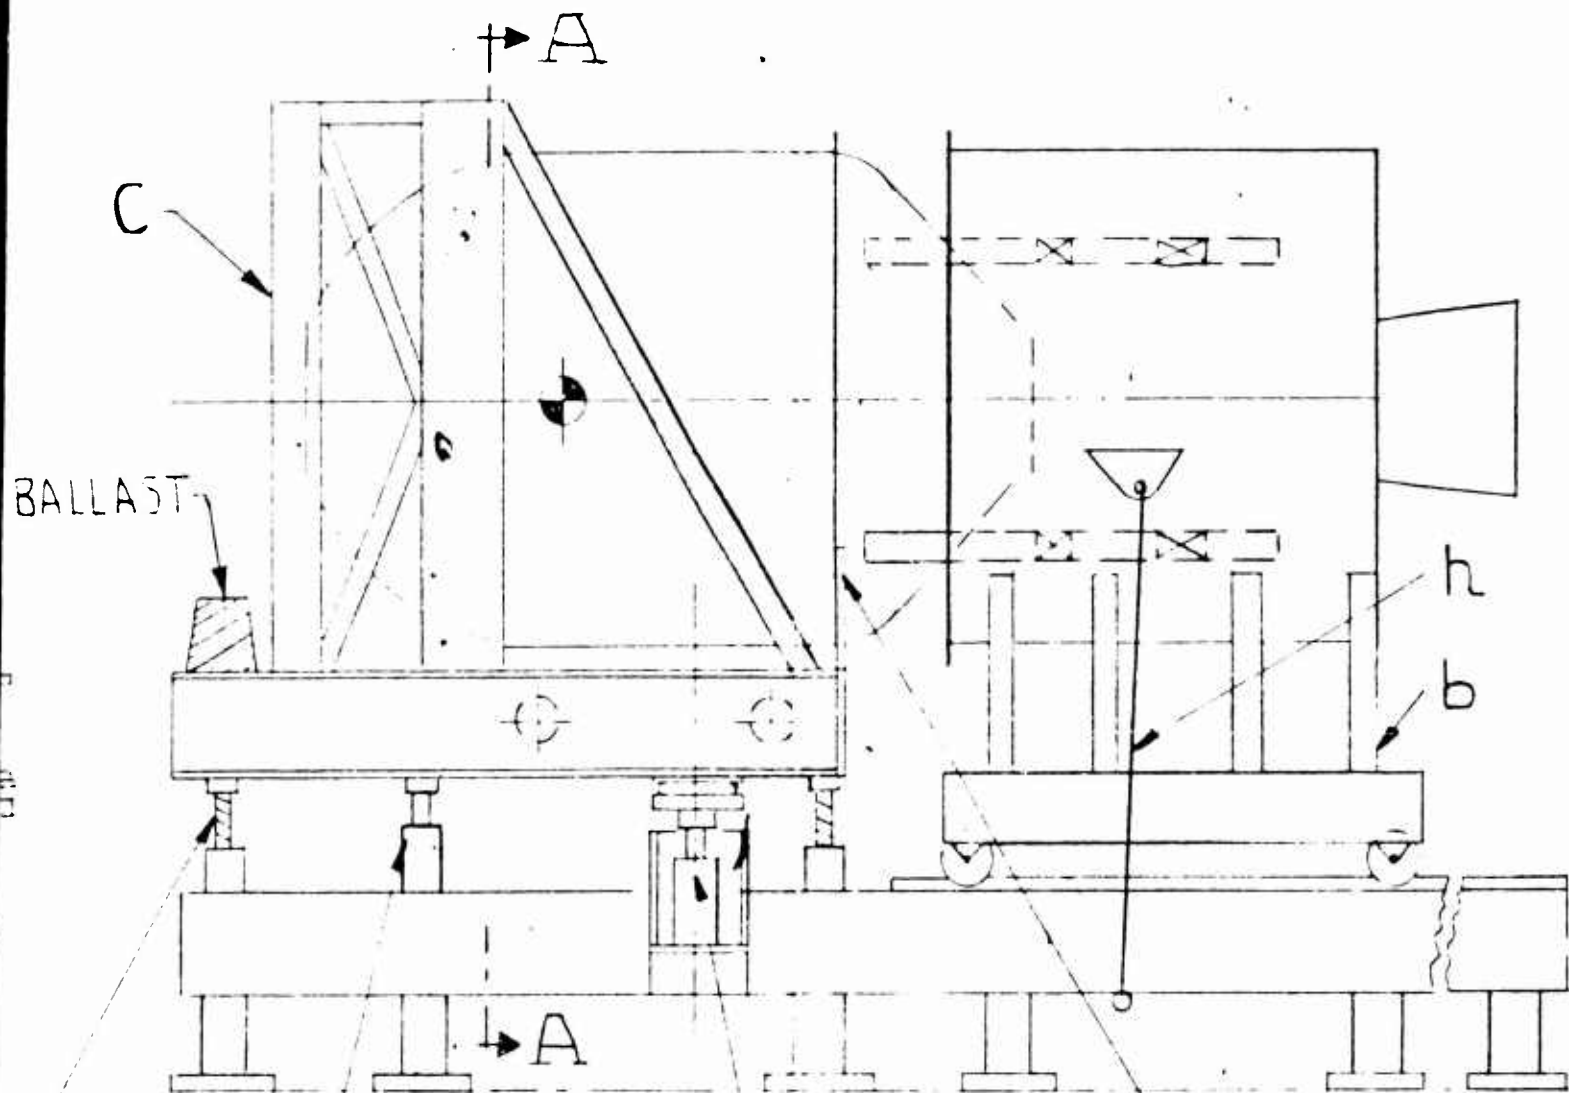
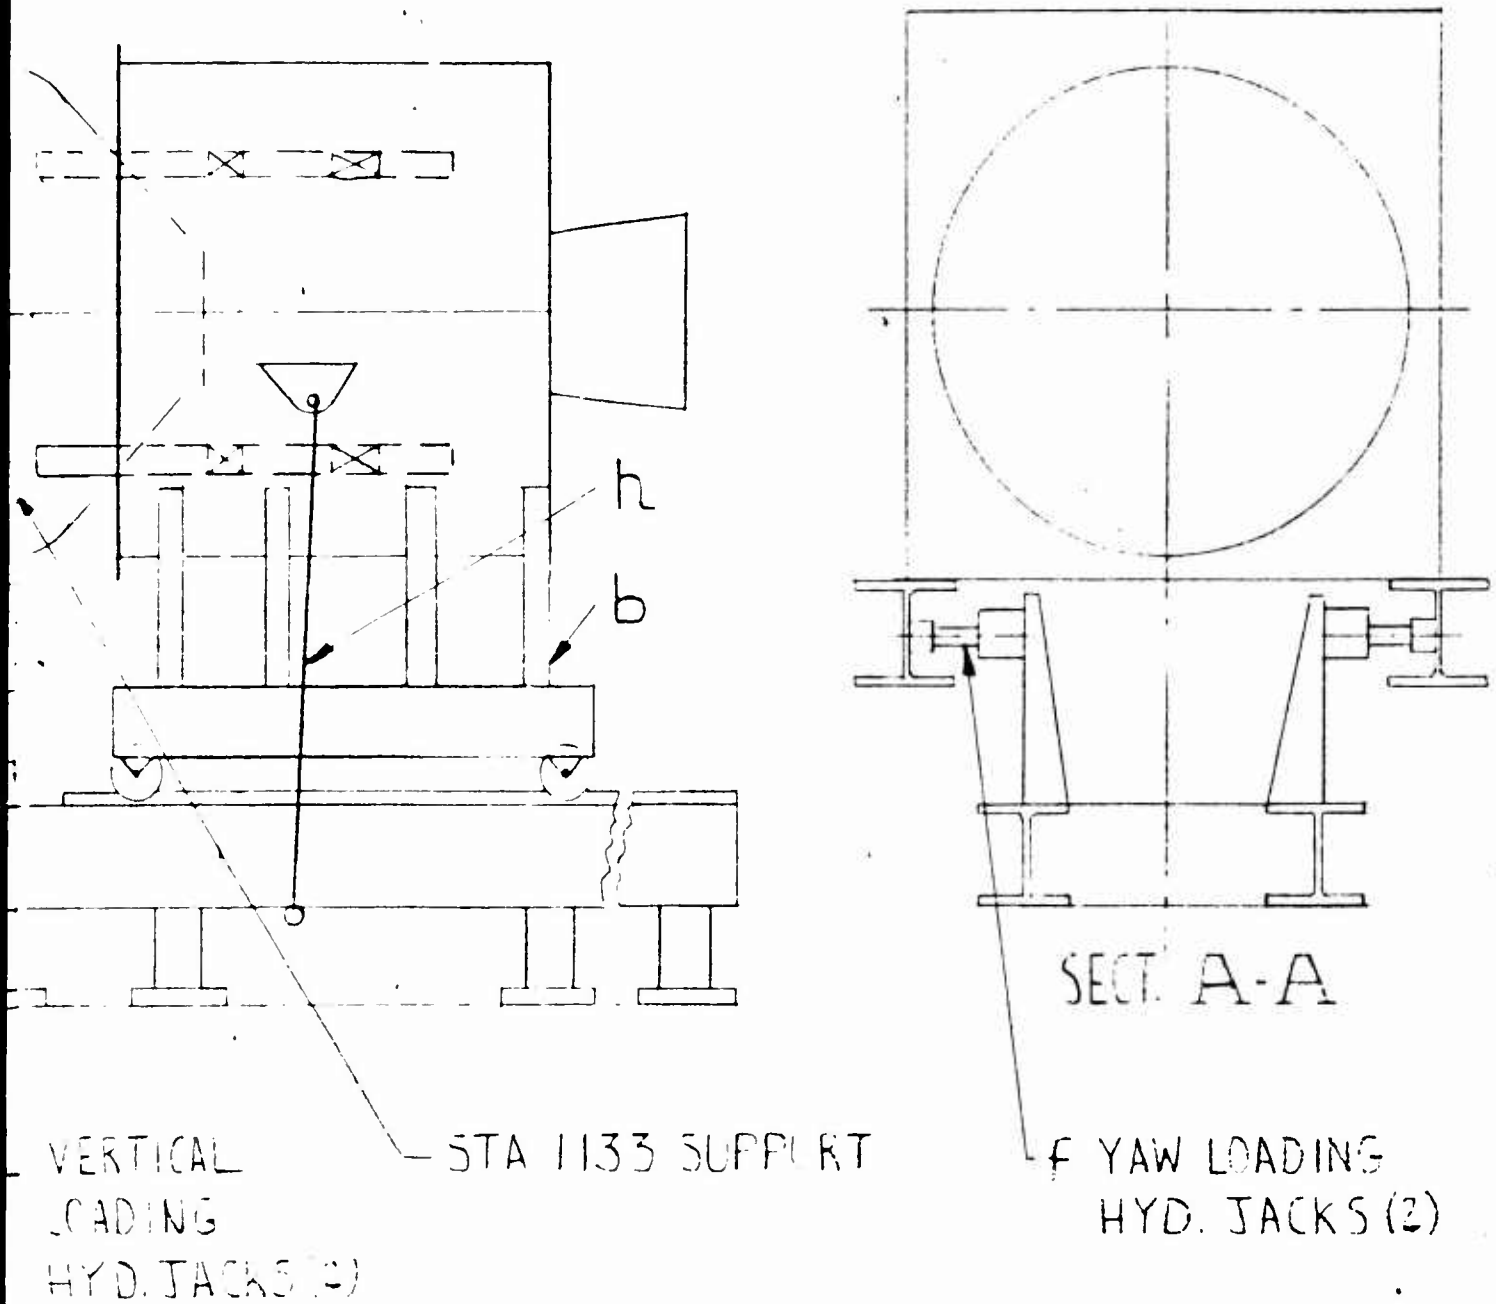
FIGURE 4.2.1

C AUXILIARY
HYD. JACK (1)
ON 4

4 VERTICAL
LOADING
HYD. JACKS (2)

2 TEST STAND

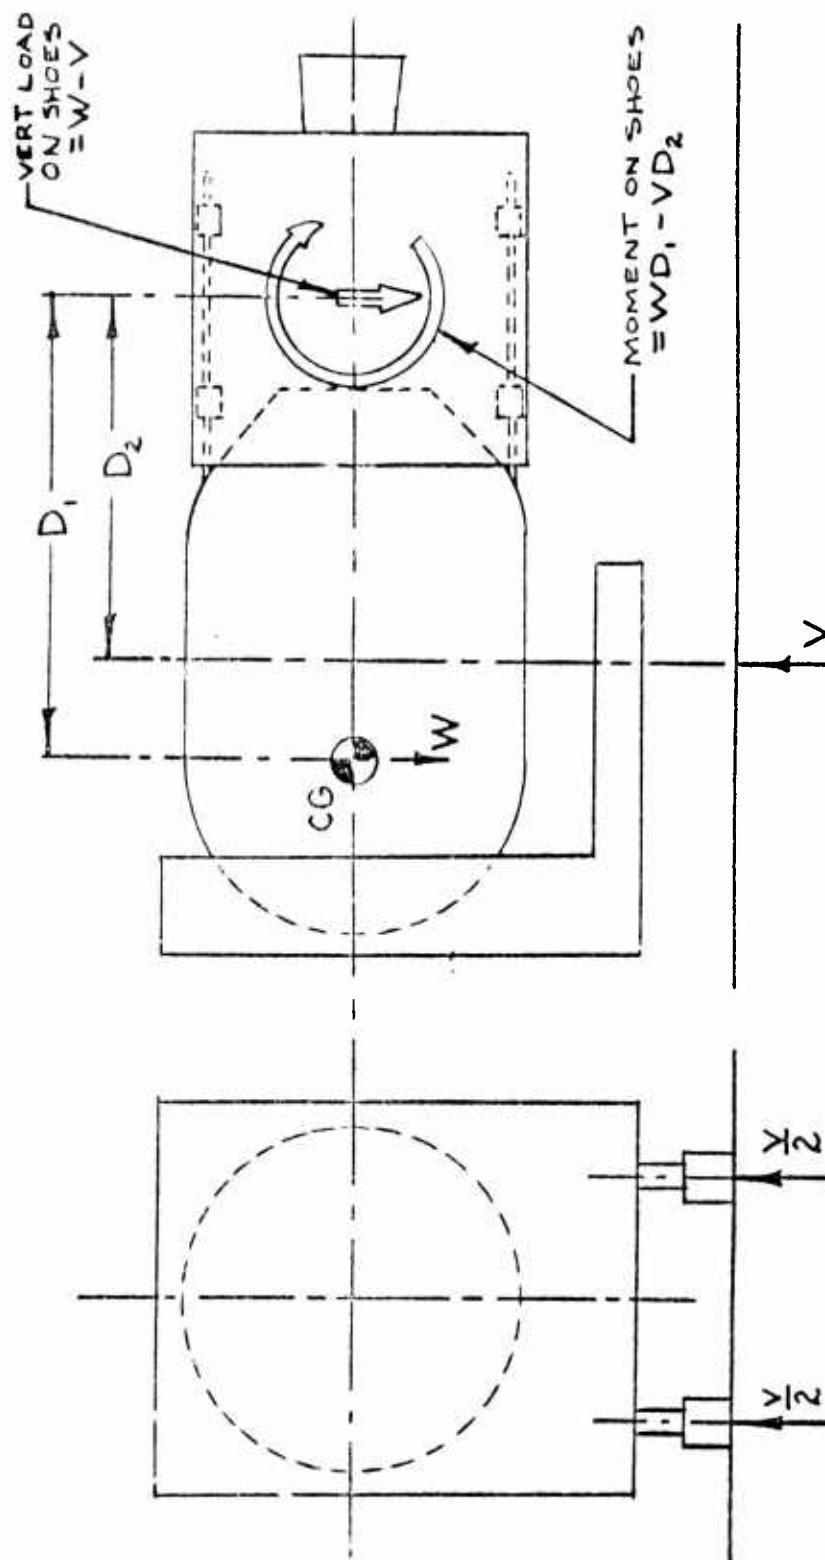
FIG. 4.2.2

LOADING FIXTURE SCHEMATIC
LOADS & REACTIONS ON DUSTAINER SPECIMEN

The net result when the test condition was attained is shown in Figures 4.2.2, the sustainer section being in equilibrium under the system of loads illustrated.

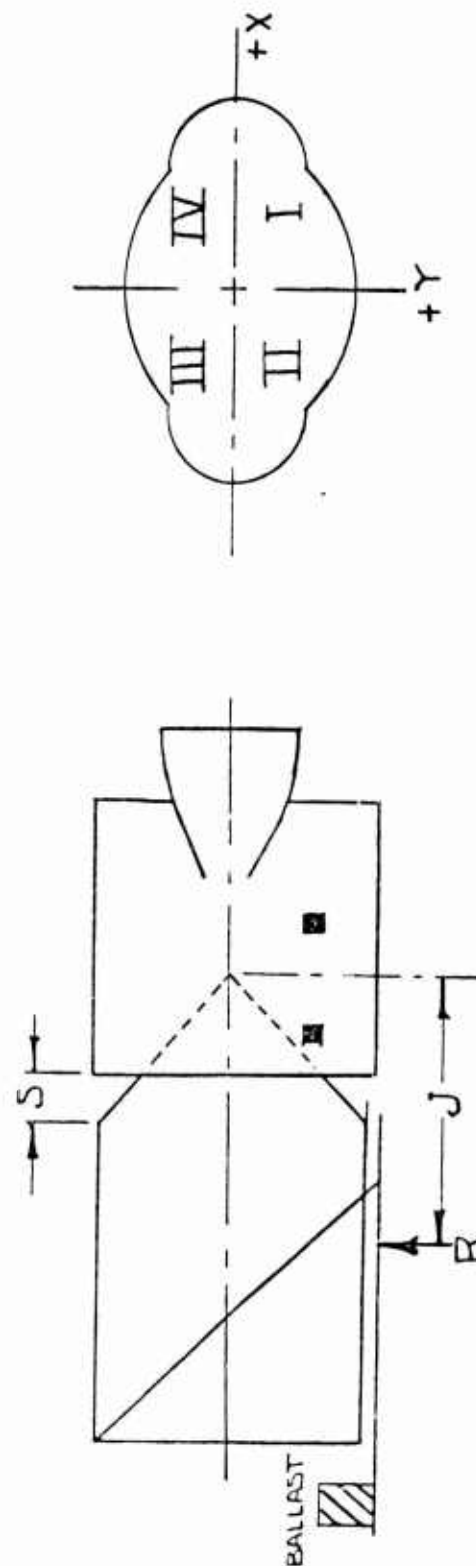
FIG. 5.2.1

SEPARATION DISTANCE "S"	BOOSTER LOADS		M _{Y-Y} (IN-LB)	M _{X-X} (IN-LB)	JACK REACTION "R" (#)	JACK DISTANCE "J" (IN)	BALLAST (#)
6"	SHEAR PARALLEL TO X-AXIS (#)	SHEAR PARALLEL TO Y-AXIS (#)	185,000	0	15,936	103.9	0
12"	3,750	285	185,000	0	21,195	98.7	2,000
30"	3,260	0	185,000	0	20,705	116.8	2,000
48"	3,260	0	185,000	0	21,205	134.7	2,500
56"	1,800	0	185,000	0	19,244	152.7	2,000

WT. OF MOCKUP STRUCTURE AND TANK = 15,445 #

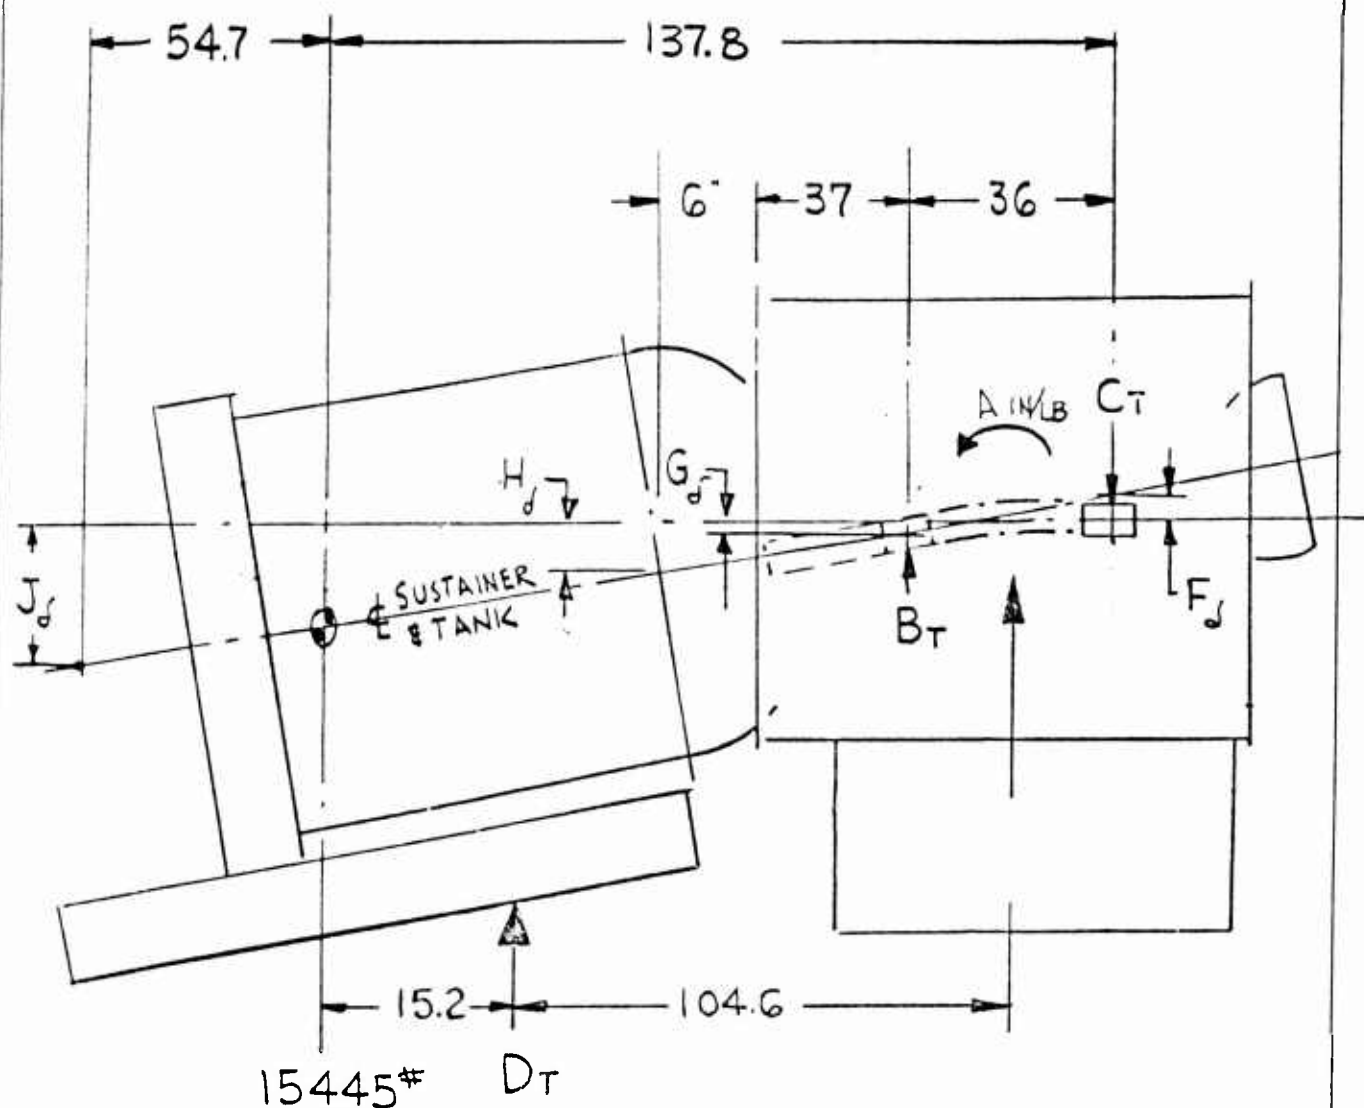
FIG 5.2.2

6" SEPARATION LOAD / DEFLECTION TEST TEST IB

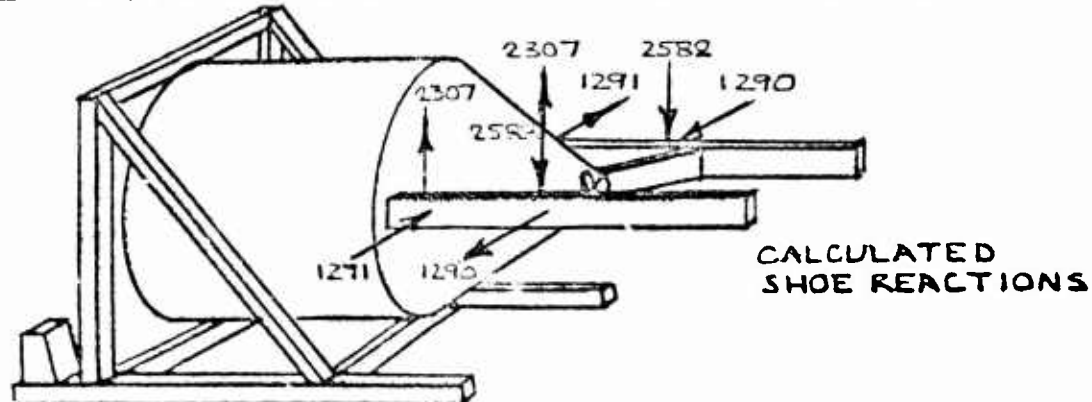
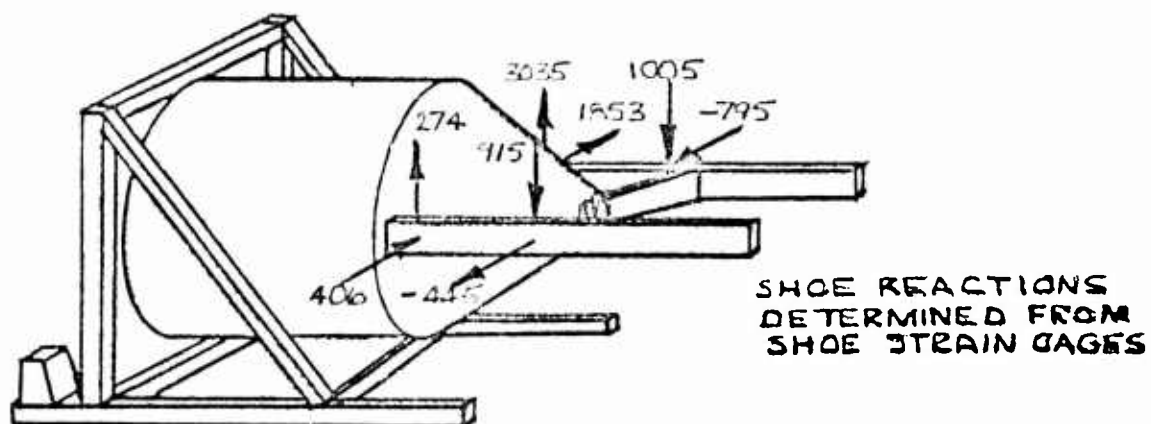
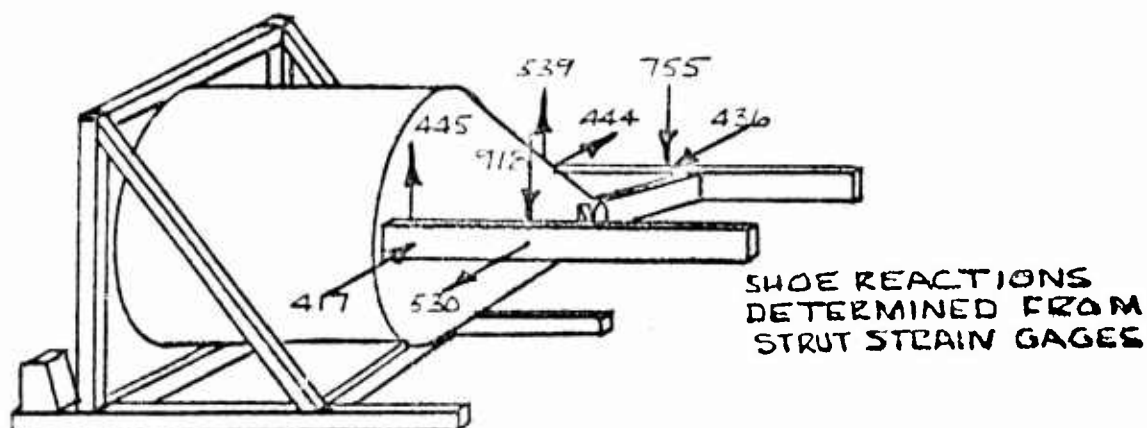
FIG 5.2.3

JETTISON SHOE REACTIONS-6" SEPARATION

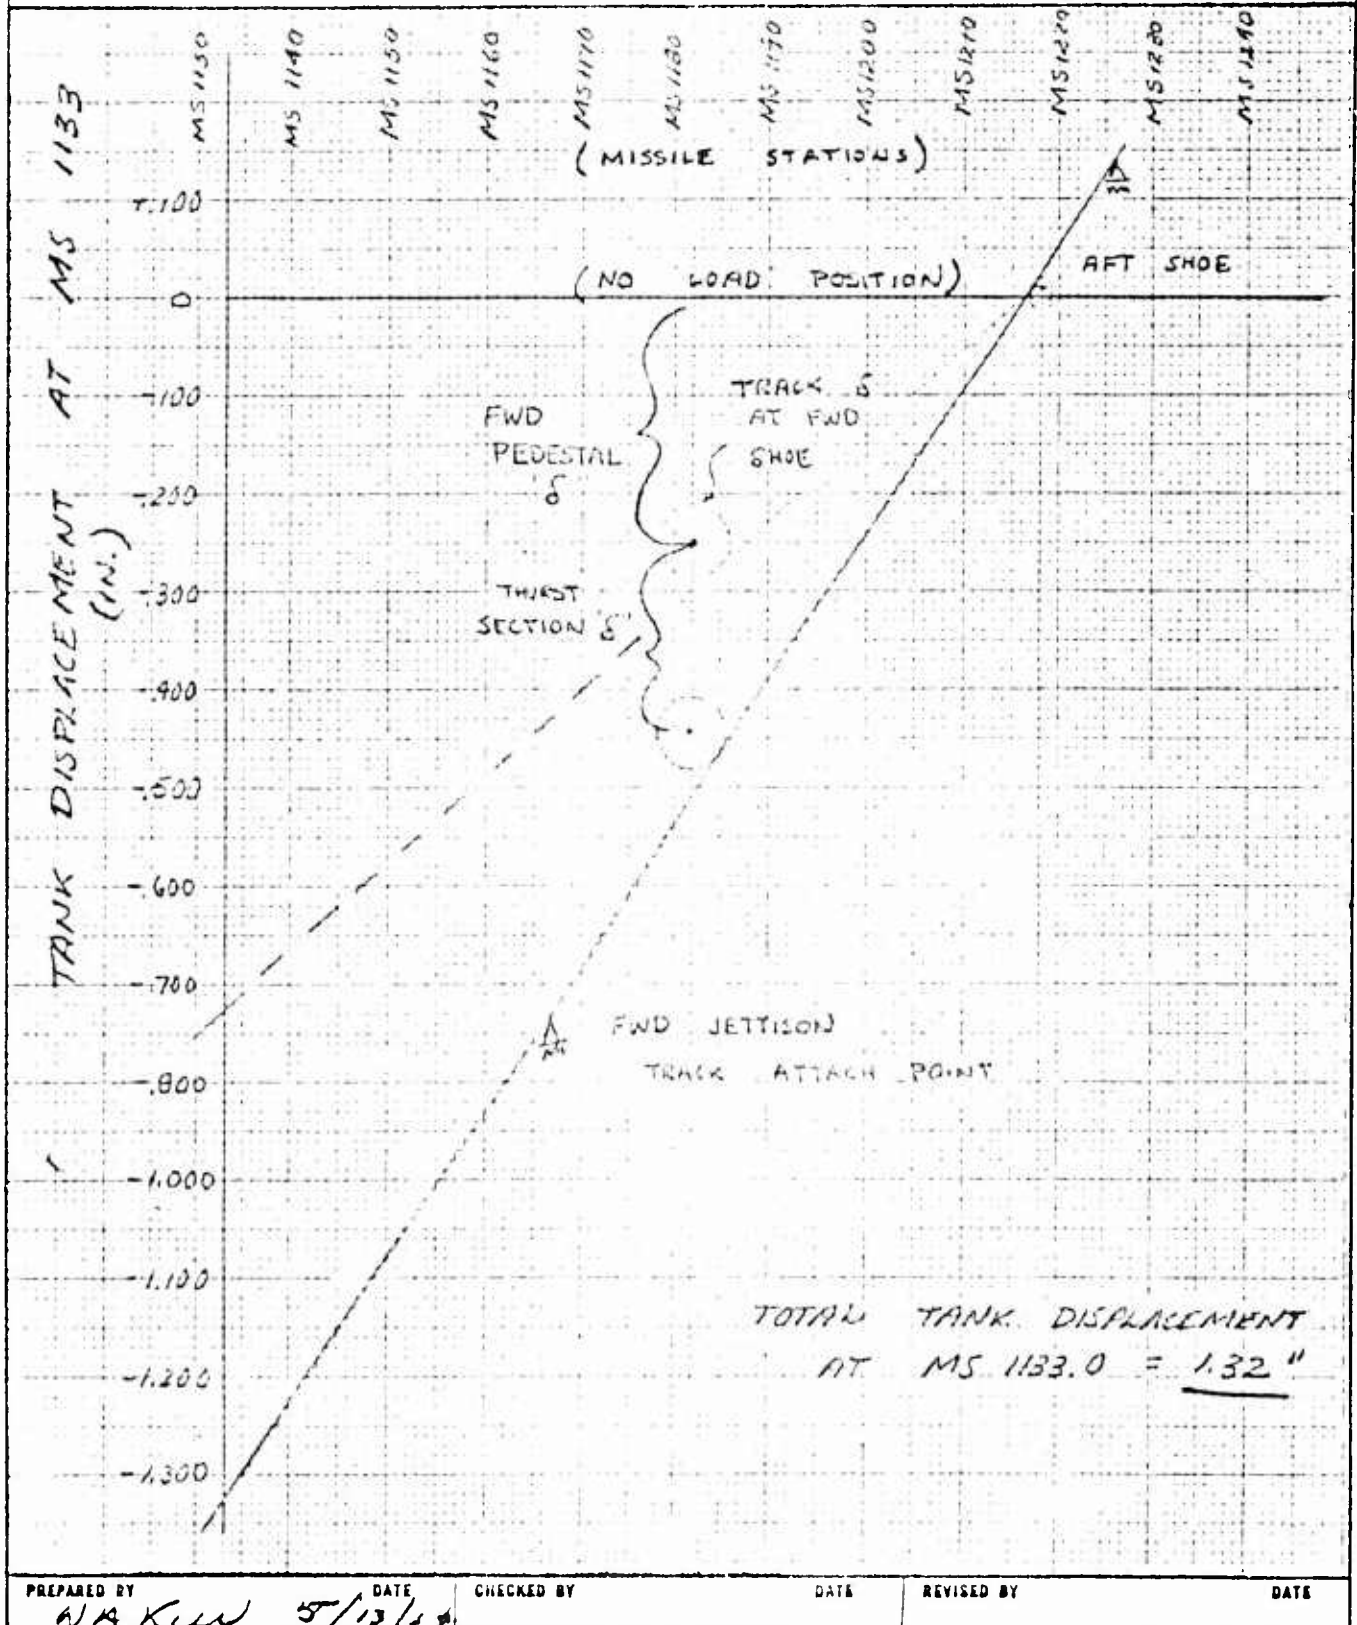
FIG 5.2.5

FIGURE 5.2.4 DISPLACEMENT AT MS 1133 DURING TEST 2D.

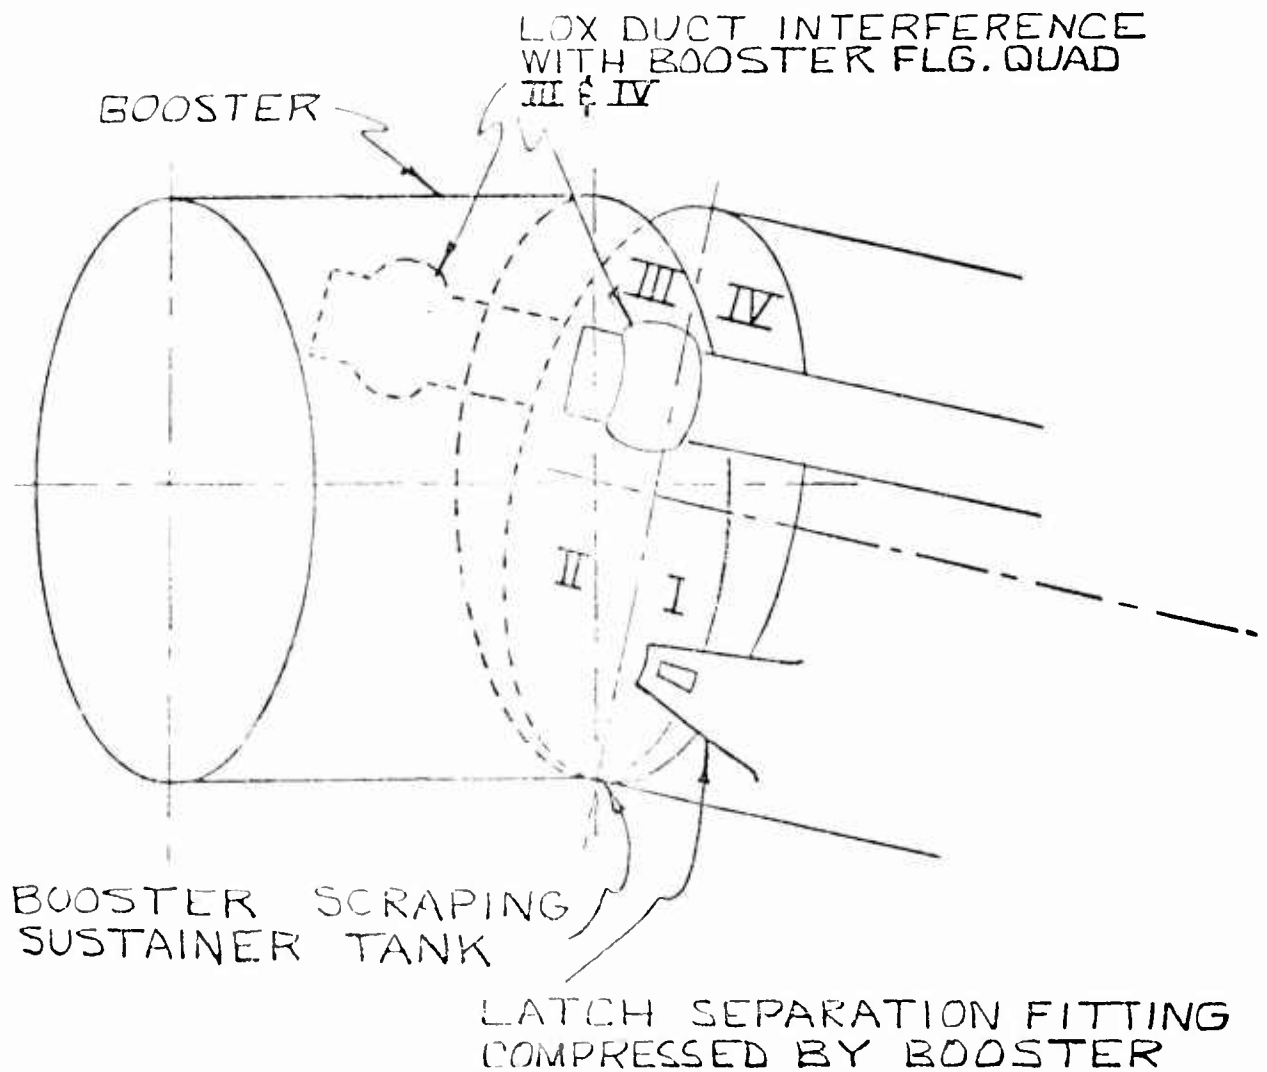
12" SEPARATION LOAD/DEFLECTION
INTERFERENCES AT LOADING
(AFTER FAILURE OF QUAD. IV
PEDESTAL)

This test was terminated primarily by a failure of the QIV forward jettison slide pedestal. However, at this point, the limitation encountered in the six inch separation test had again been reached, - the lower forward edge of the booster was in contract with the fuel tank skin. The upper forward edge of the booster was also contacting the LOX staging valves.

The jettison slide pedestal failed at the upper forward corner. Similar specimens described in section 5.8 failed in the same manner.

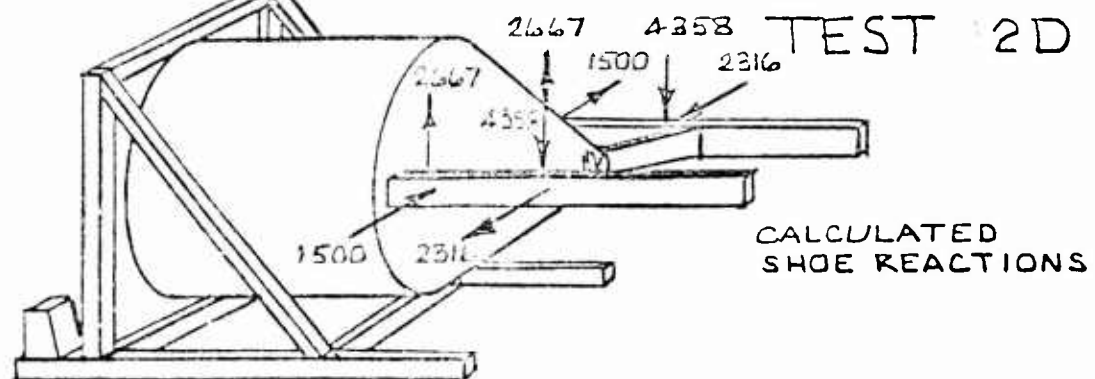
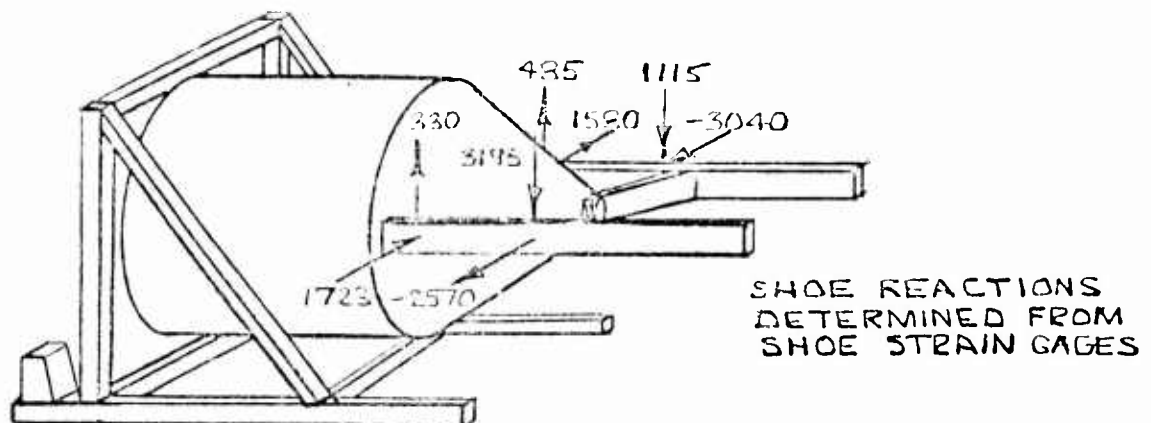
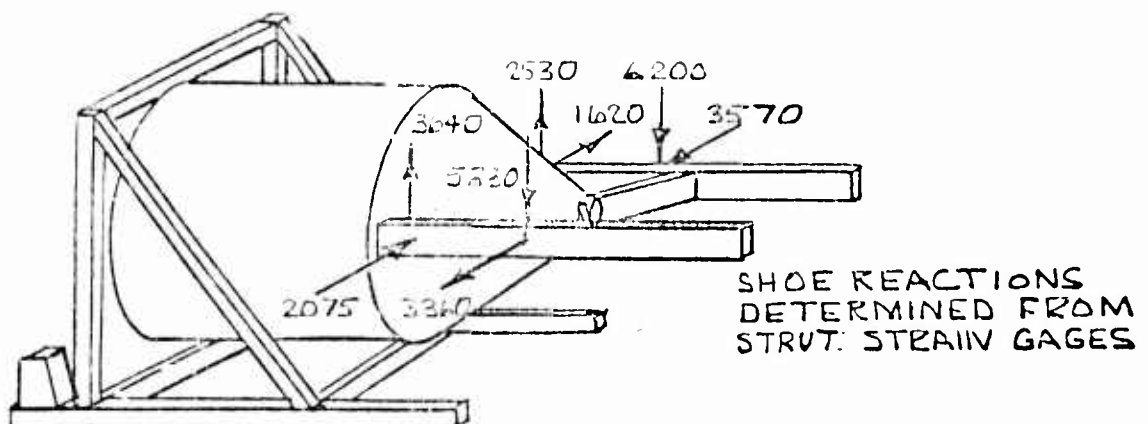
FIG 5.2.6

JETTISON SHOE REACTIONS-12" SEPARATION

Figure 5.2.6 compares the calculated shoe loads against those obtained from strain gages mounted on the shoes and on the forward attach struts. Again the data obtained from jettison shoe data differs from calculated values in both distribution and sign. The shoe loads obtained from the strut data shows better agreement in sign but the magnitudes are quite large. These loads occurred after the pedestal failure. The Quad IV shoe after failure was shown to be capable of taking only 800 lb. shear (see Section 5.8). This capability was augmented, however, by an instrumentation plate which caused interference between the pedestal and booster. The 2530 pound recorded load is not as great an error as would first be assumed. It may be concluded that the required moments and shears had been introduced in the test specimen but that the pedestal failure and interferences caused differences in distribution.

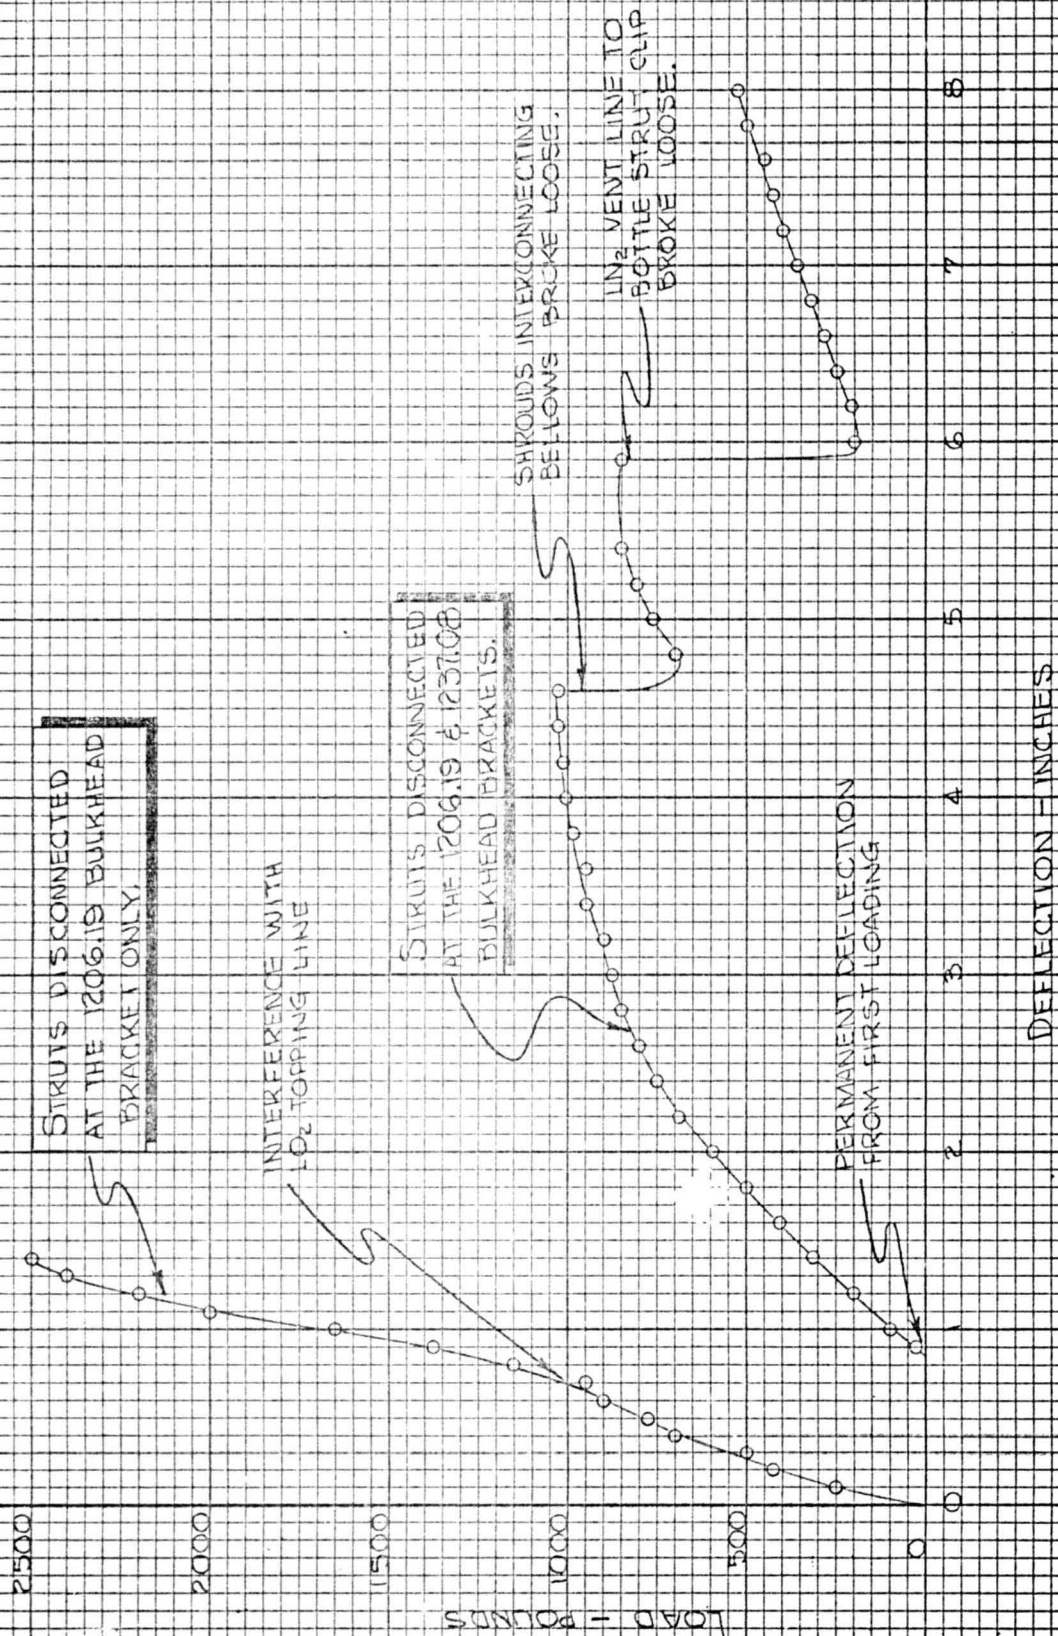
HELIUM BOTTLE INTERFERENCE TEST

It was concluded that sufficient restraint on the bottles is afforded by the associated plumbing, etc., to render interference by the bottles with the sustainer highly improbable even after a failure of the bottle structure.

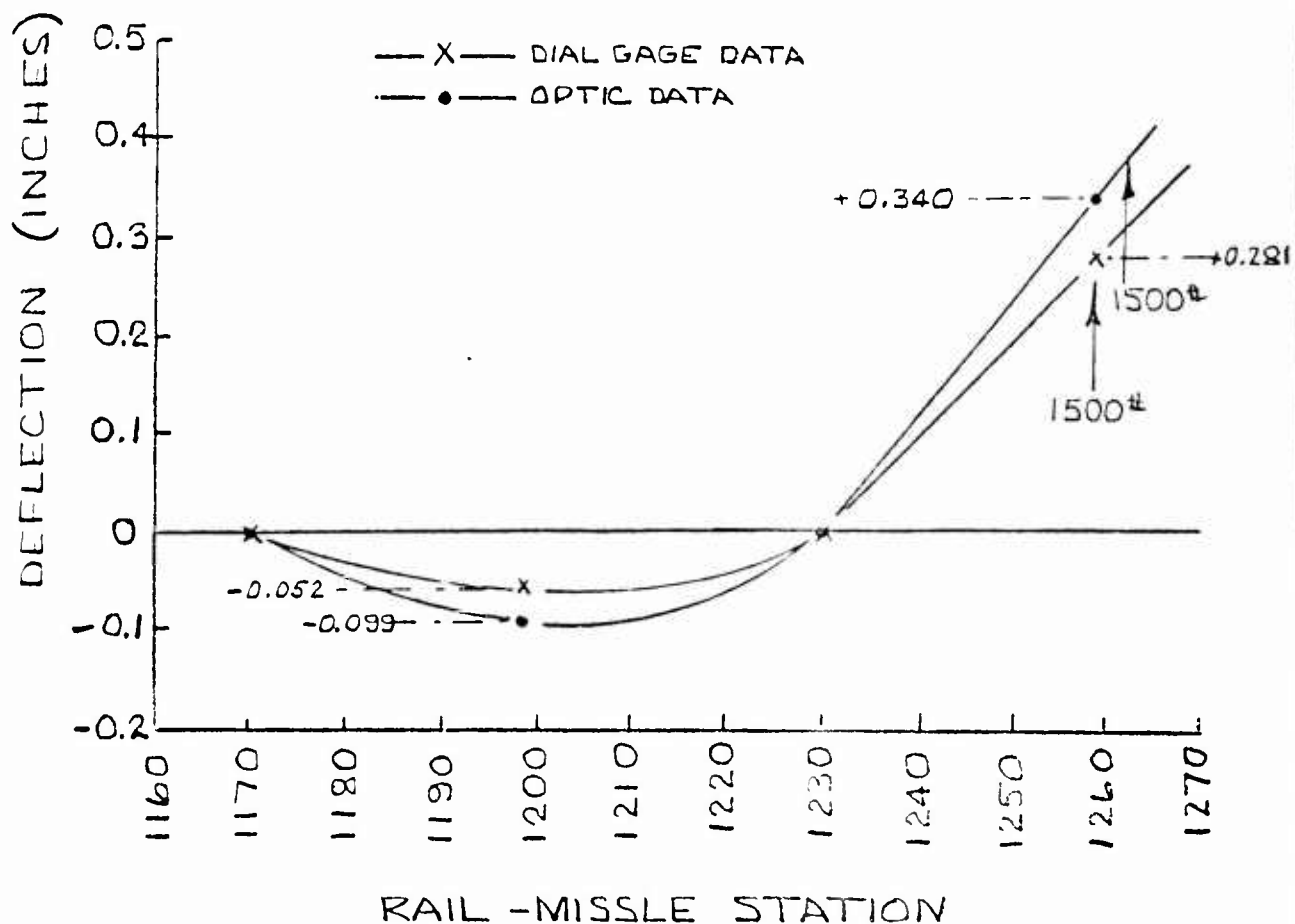
FIG. 5.5.1

COMPARISON OF OPTIC DATA AND
DIAL GAGE DATA

RADIAL DEFLECTION
QUAD IV RAIL
TANK PRESSURE - 12 PSI

The deflections measured did not vary significantly with changes in tank pressure. The deflections measured at the forward attach point were small. Figure 5.5.1 compares the data obtained by the optic method with data obtained by dial gages. Comparison of test data and calculated deflections demonstrated a close correlation. This comparison was made after correcting for the test deflections of the forward and "A" frame attach points. Some rotation was noted at the "A" frame due to tangential loads applied to the rail.

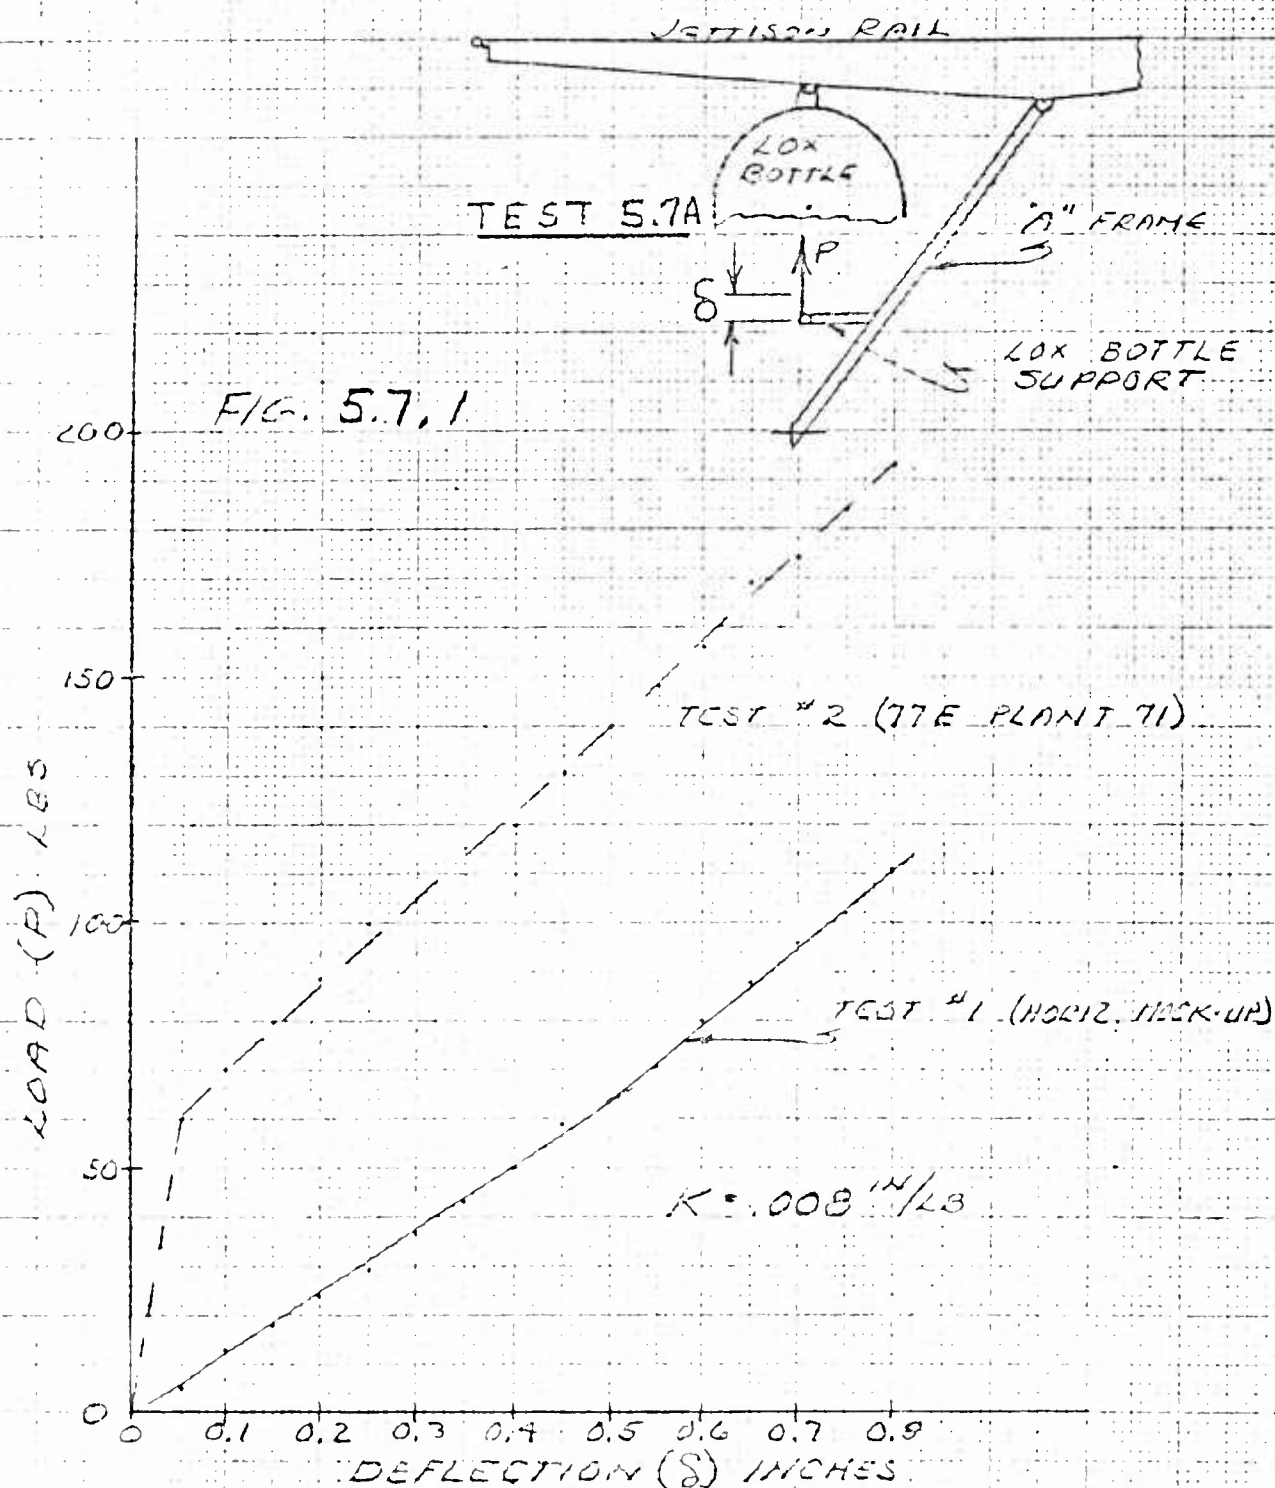
LOX BOTTLE BRACKET
(VERTICAL DISPLACEMENT)

The results show the top of the lox bottle could move vertically 0.8 inches, laterally 0.7 inches and rotate 7.0 degrees without fracturing any of its supports. This is also representative permissable track to "A" frame relative movements, which are of the order of 6 to 8 times the relative movements expected from any possible track loading condition.

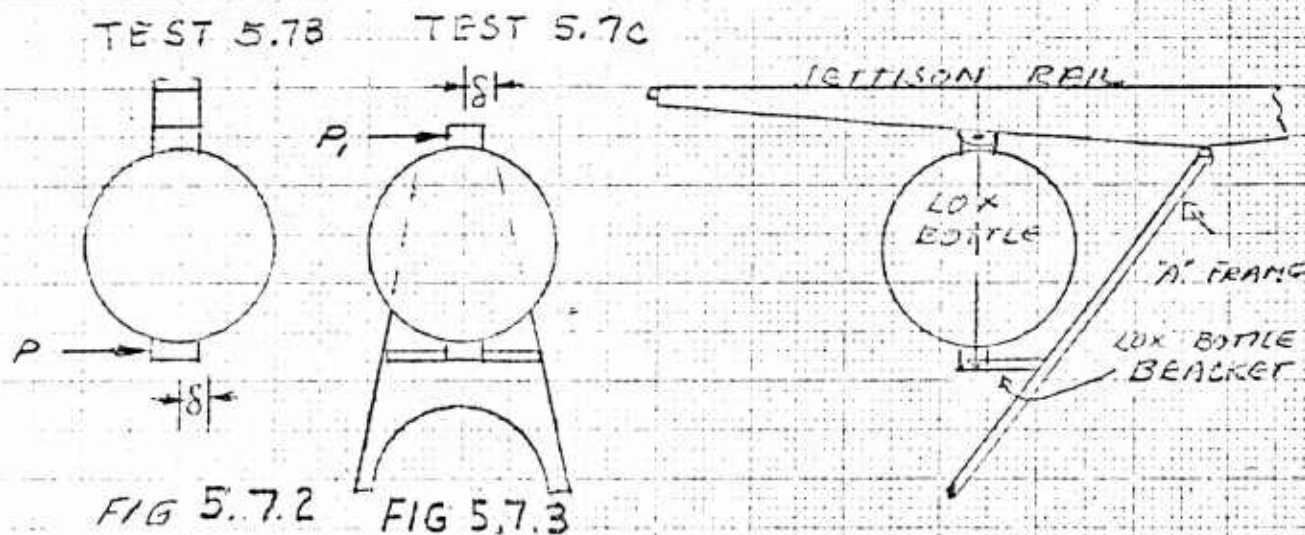
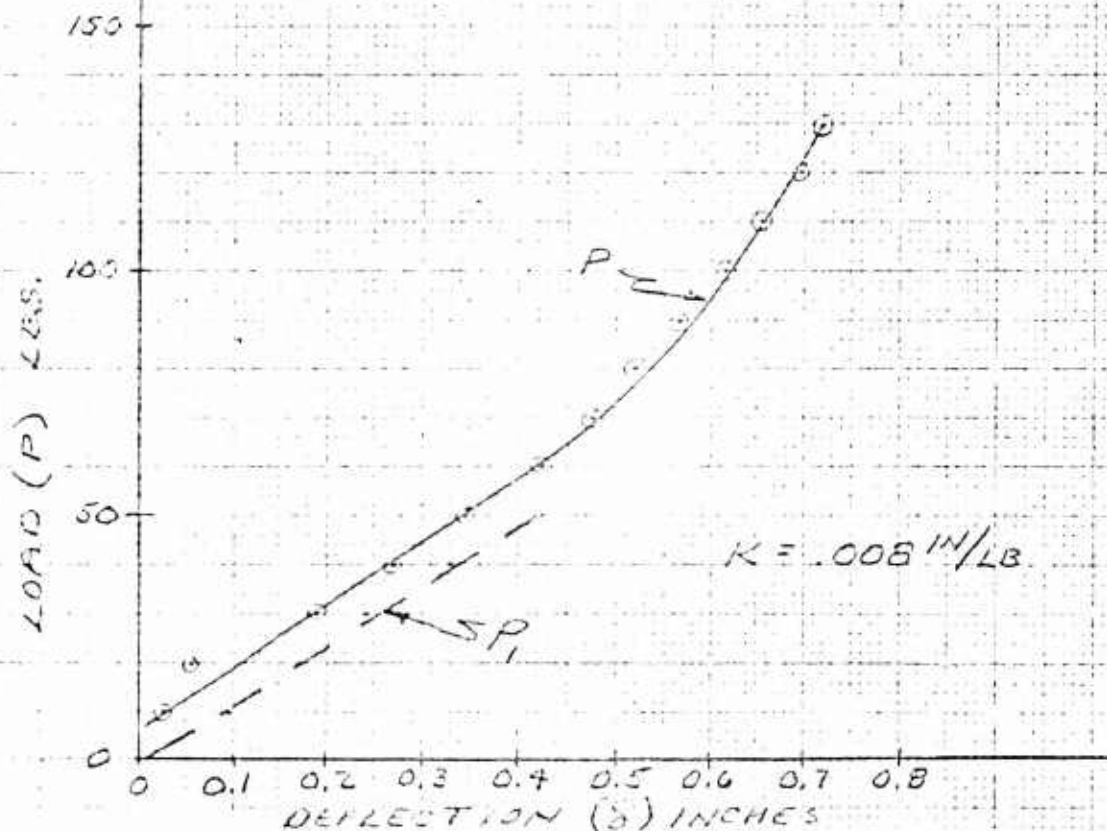
LOX BOTTLE
(SIDE EXCURSION)

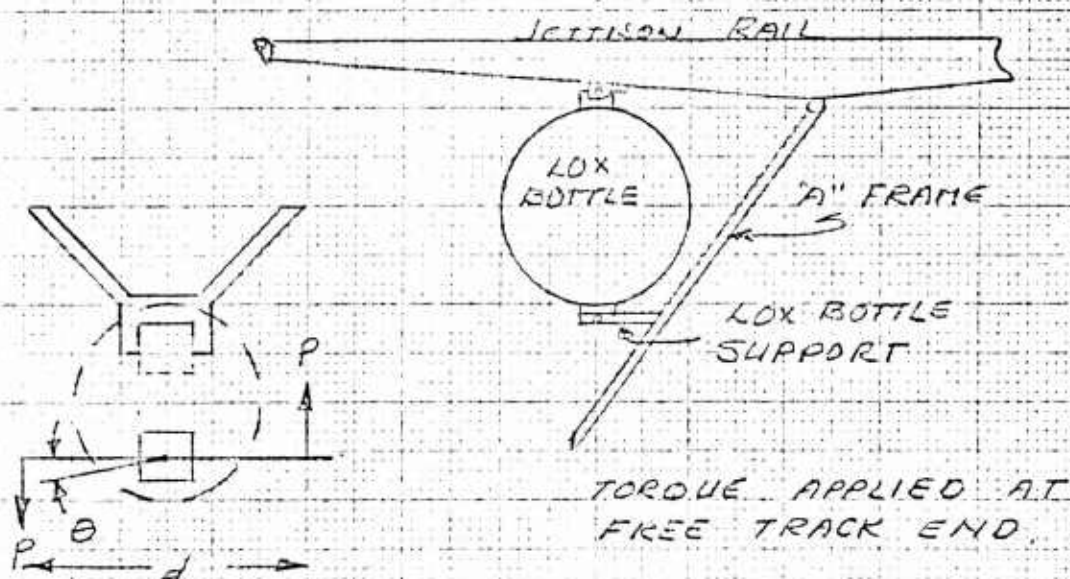
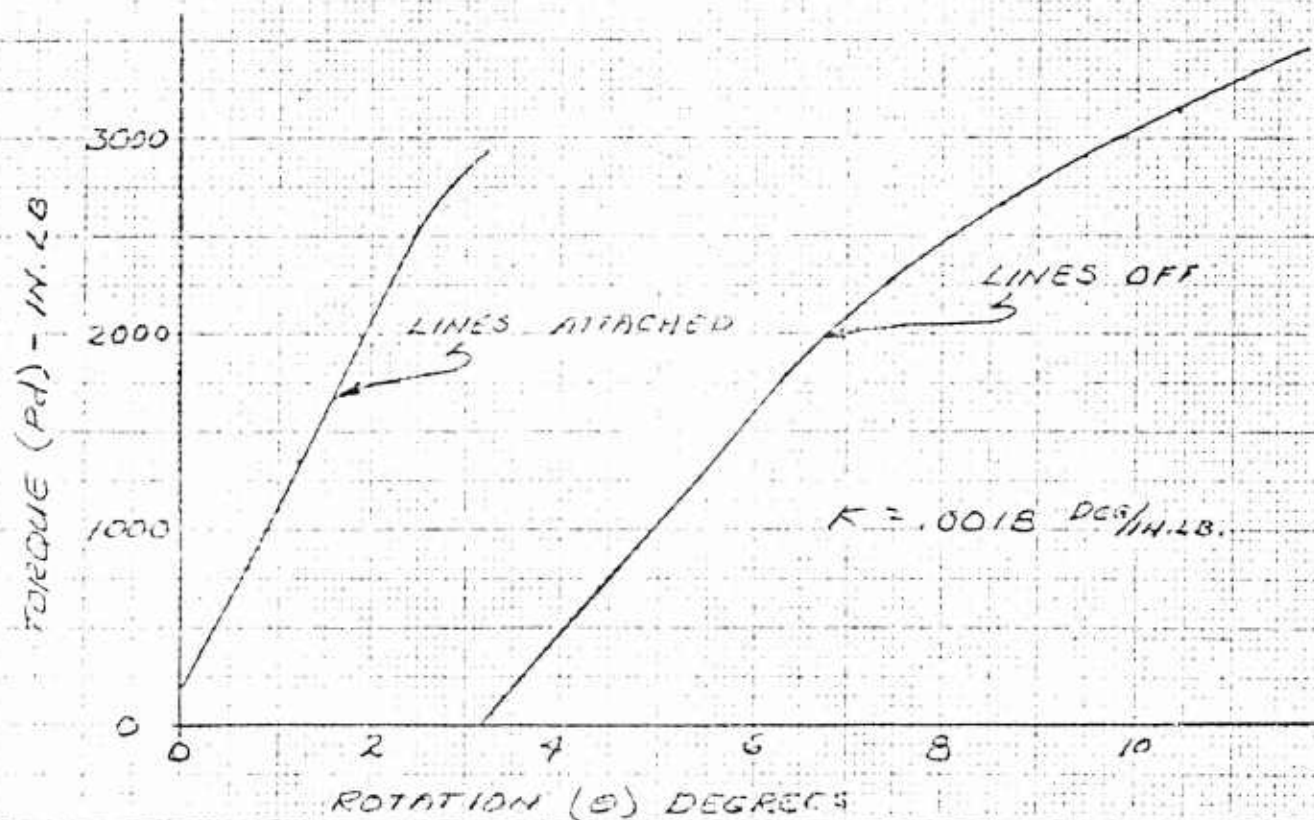
FIG. 5.7.4

LOX BOTTLE TORQUE (ROTATIONAL DISPLACEMENT)
